Buchans Ecological Engineering Treatment Assessment

Long-term performance evaluation and Site Visit Report (2009)

Margarete Kalin

October 2009

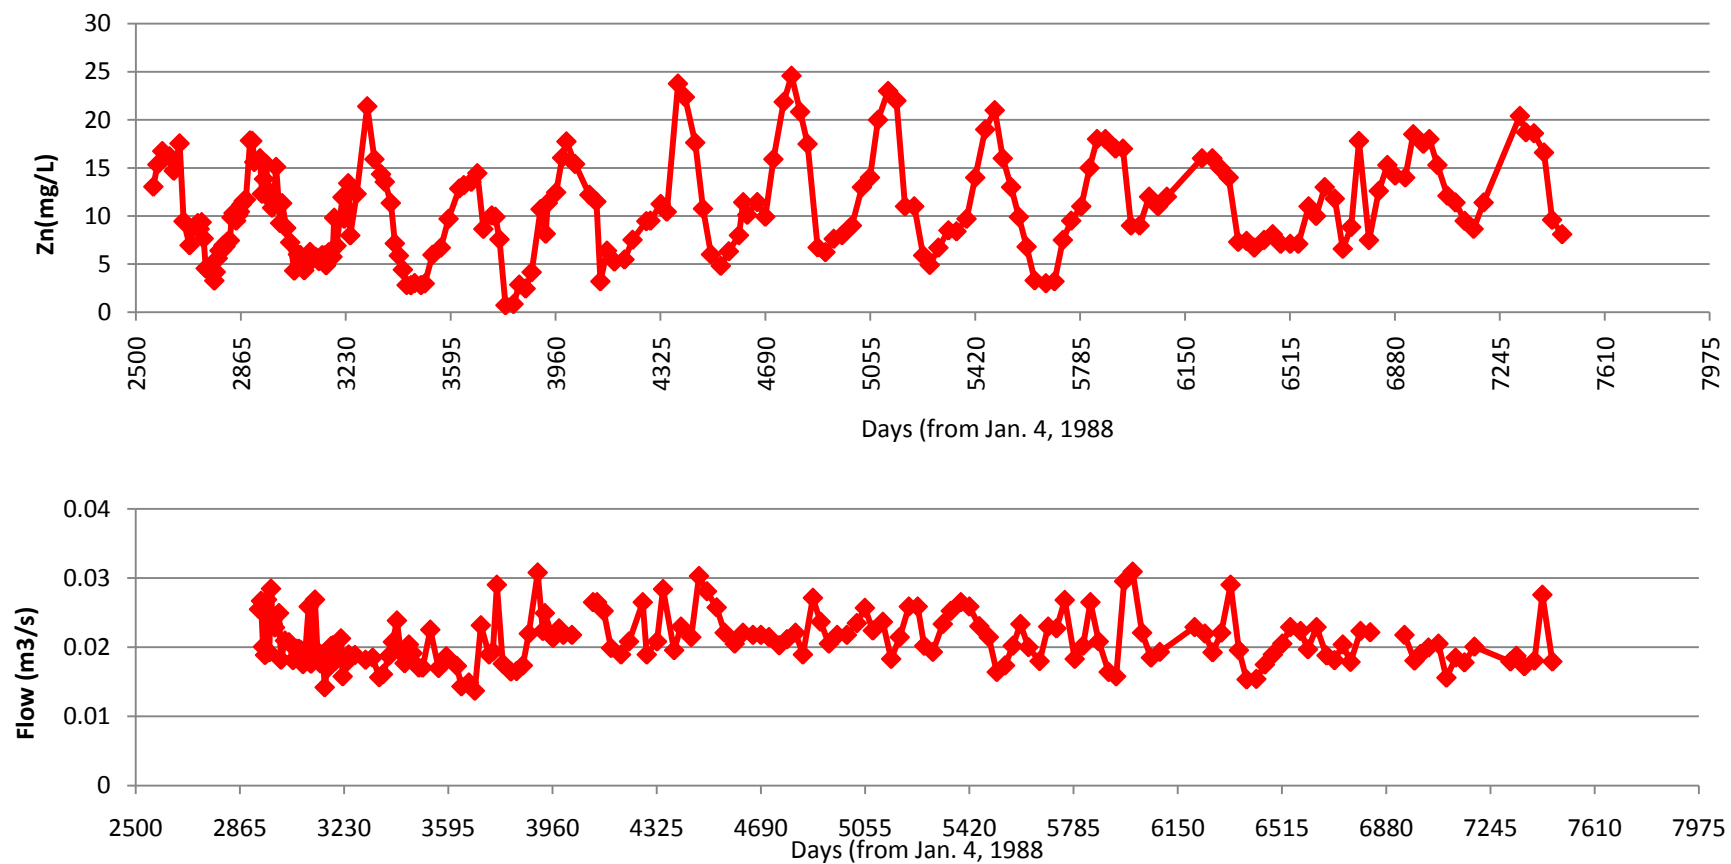
Figure 9. Polishing Ponds performance (1993-2008) (Final Boojum effluent corresponds to Pool 13 and 17)

In Figure 9, the performance of the final effluents of the polishing system is given. The initial seasonal fluctuations are very pronounced up to day 5700 or August 2003. It is evident that the summer low concentrations are decreasing from that time on. This is likely a reflection of the reduced oxidation capacity of the system. Apparently sugar was added at the pumping station at one point in time. This addition had likely little effect in the pond performance as sugar is water soluble and would have left the system within days. The flows to the system have remained the same since Boojum worked there (see Fig 9). The initial large variations in the flows were due to the gradual additions of additional effluent streams up the 1999.

Further additions were reported to have been made to the OWP and the OEP in the form of biosolids. This was likely quite destructive to removal as these solids promote microbial iron reduction. This will take place initially rather rapid , due to the easily degradable carbon utilized by iron reducing microbes followed by a slower phase as the recalcitrant or hard to degrade carbon will have its effect in the long term.
